## **Chevron's Use of EonCoat® To Prevent Corrosion On Steel**

Abstract: The paper will discuss how Chevron U.S.A. has been successful in using EonCoat® to prevent atmospheric corrosion and using a high temperature version of the coating to prevent corrosion under insulation (CUI). Chevron's Benjamin Chaloner-Gill, Ph.D., Senior Advisor, Materials and Corrosion, R&D, is the senior author of the paper and will deliver the lecture at EUROCORR 2018. The resulting alloy forms a magnesium iron phosphate alloy layer to prevent atmospheric oxygen and moisture from reaching the substrate.

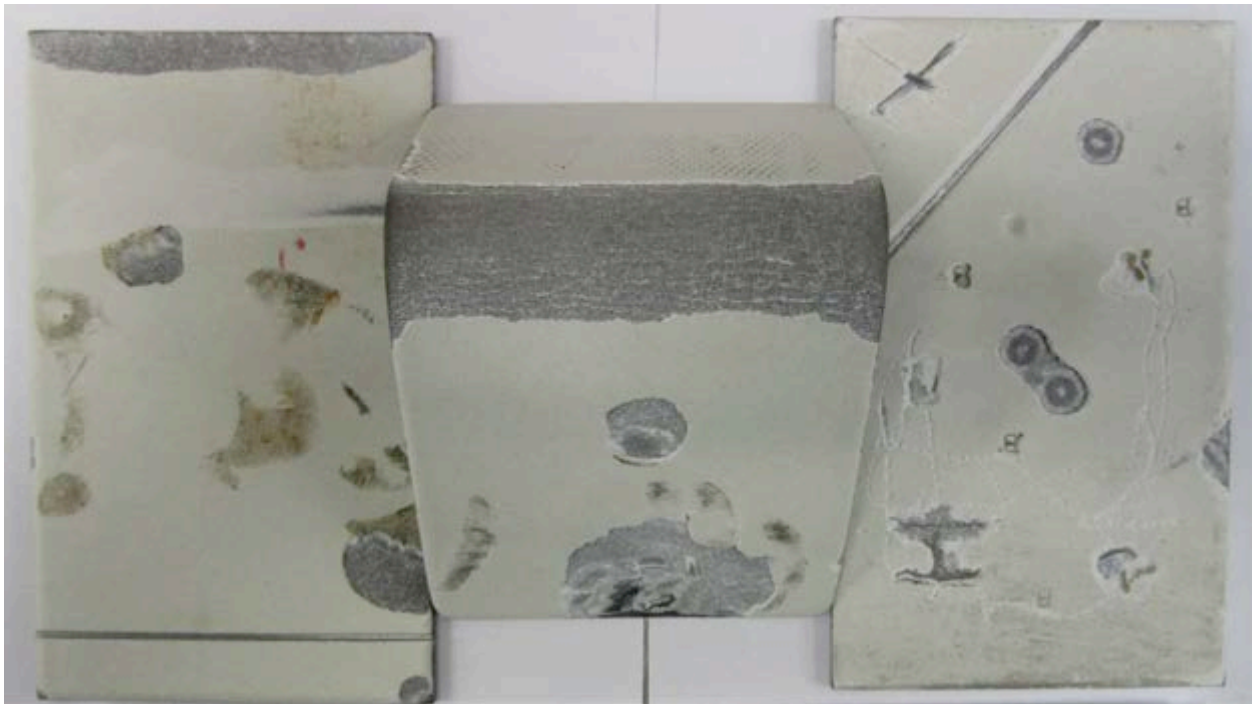
To test the mechanical integrity of EonCoat, panels were intentionally damaged. Damage was inflicted in a number of different ways – (i) Impact damage with a ball being dropped on the panel, (ii) The panel was dropped from a height of 3-4 meters onto the cement, (iii) A saw blade was used to make a cut like mark in the protective layer (but not cut through the steel itself), (iv) Various hardness tests (designed to inflict mechanical damage) were done on the panel, and (v) A mechanical polisher was used in some areas. In the most extreme case, one of the panels was bent at a 90° angle. This bend did bring new steel to the surface. Figure 1 shows the panels after damage and before B117 exposure.

*Figure 1 – EonCoat panels with intentional mechanical damage.*

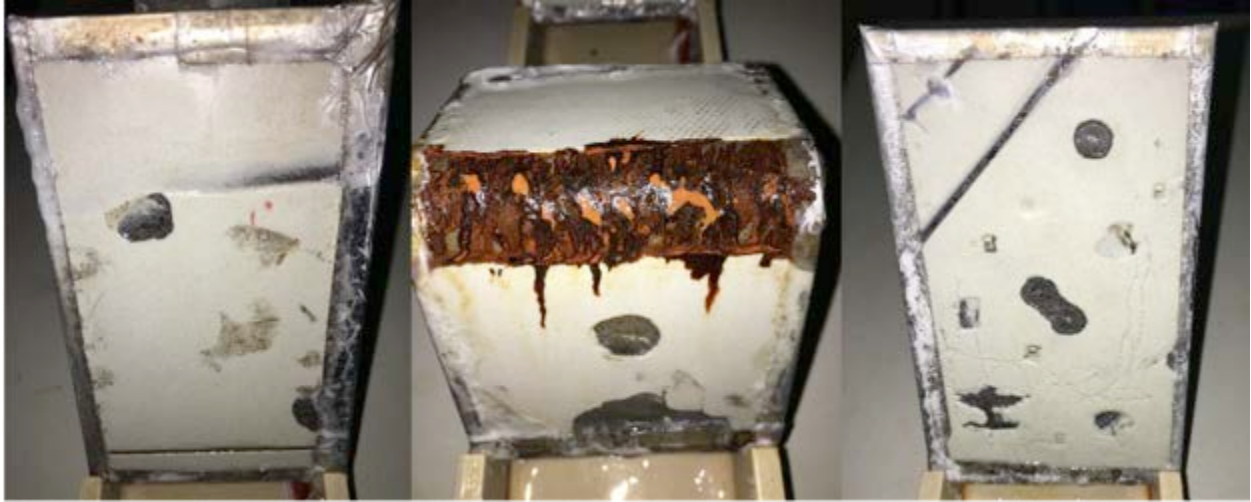
Then the panels were subjected to ASTM B117 conditions; the figures show the duration time for the panels. In the pictures below, we show the panels before B117 testing and then after 335 hours (Figure 2) and after 1,870 hours (Figure 3). In all cases, there is not rust in the areas where the panels were intentionally damaged, aside from the 90° bend in the panel. Again, the panels show no sign of rust. Organic coating would have failed to control the corrosion in these conditions.

*Figure 2 – EonCoat panels with intentional damage after 335 hours of B117 exposure.*

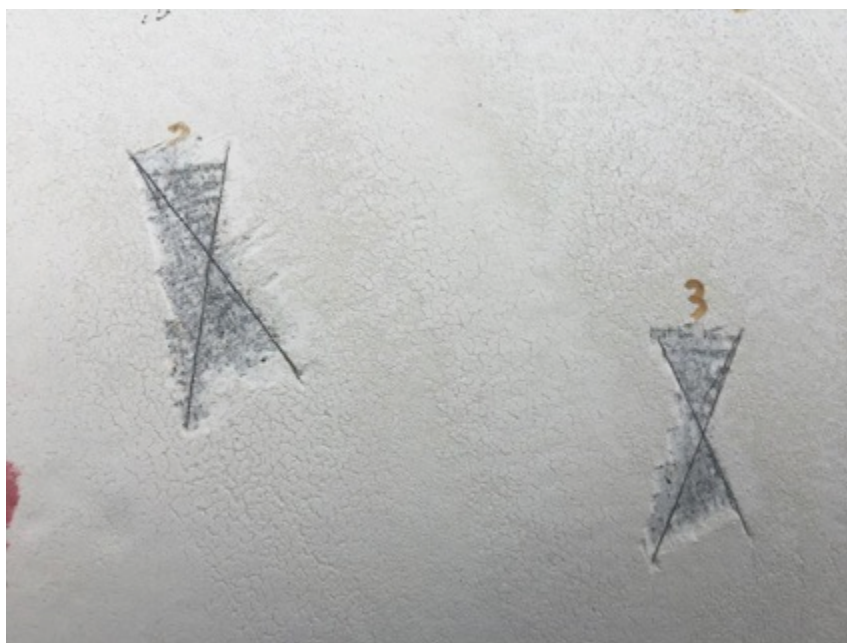
Field-testing of EonCoat in CUI conditions continues. Figure 4 (below) shows cross-cut adhesion into the coating. The cross-cut adhesion was performed in February 2018 and then re-examined in June 2018, 4 months later. The picture in Figure 4 shows the cross-cut and subsequent removal of adjacent phosphate ceramic. This picture was taken in June 2018 after the pipe had been placed back in service. The pipe service, insulated with blankets, is running at temperatures ranging from 120 to 138 °C.

*Figure 4 – Cross-cut adhesion of EonCoat – June 2018 after 4 months of being insulated and in service.*

Like the intentionally damaged panels above, again, the EonCoat shows no rust. Organic coatings would have begun to show corrosion.
